Presqu'ile

Heritage Building Stewardship Plan

Prepared by Geoff Hodgins Architect with BRAY Heritage in 2005

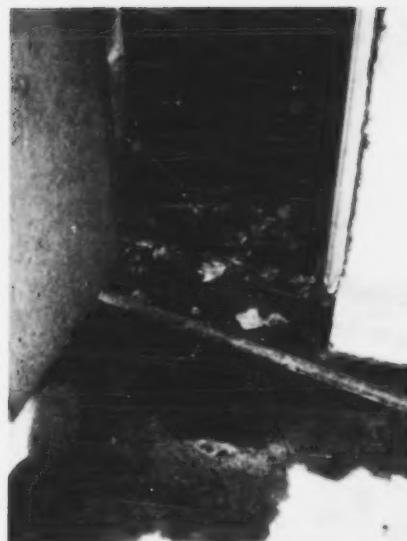
figure 28 - Basement Door

The structure has a full basement at the eastern end and a crawl space under the rest. The poured concrete is generally in good condition but water was trickling through the east wall (*see figure 29*) and under the wood sill of the exterior entry. The sill is rotten (*see figure 28*). There is evidence of mild mould growth on some basement surfaces (*see figure 30*). The plaster on one side of the interior stairwell has developed cracks over the years that appear to be expanding, probably due to the high basement humidity (*see figure 31*).

- replacement of the rotten sill on basement access door with metal frame and sill
- removal of surface mould on basement interior surfaces and installation of a dehumidifier

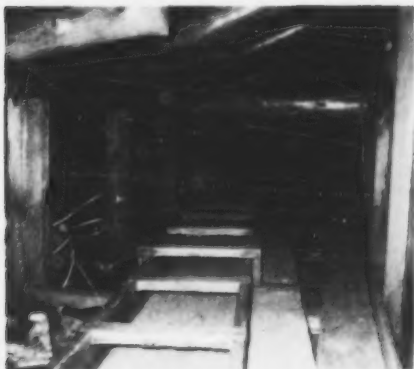
figure 37 - Pole Structure in Attic

The log pole rafters with exposed planking are in good condition. Use of un-milled framing supports is evidence that this building may not have been a complete kit and had some custom components (*see figure 37*). A portion of the roof on the lakeside is sheathed in narrower boards, which supports Clarke family recollections of damage caused by flying debris resulting from an explosion during the construction of the lakeside well.
